ACTIVITY-BASED SAMPLING SUMMARY REPORT OPERABLE UNIT 4 LIBBY, MONTANA, SUPERFUND SITE

June 2, 2010

Prepared by:
U.S. Environmental Protection Agency
Region 8
Denver, CO

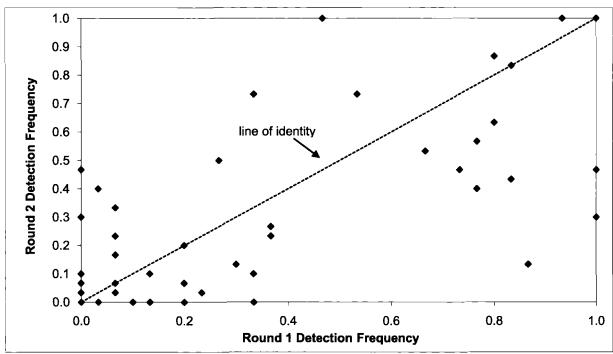
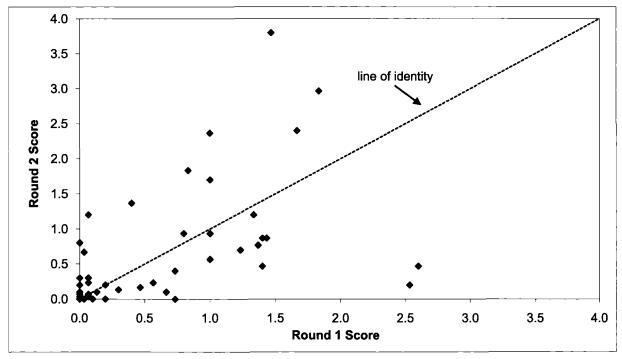
Figure 4-3
Between Round Variability in Visible Inspection Data

Panel A: Visible Vermiculite Detection Frequency

Panel B: Visible Vermiculite Weighted Score

One visible vermiculite weighted score is off-scale (Round 1 = 3.7, Round 2 = 7.5)

Restricted to 30-pt composite samples.

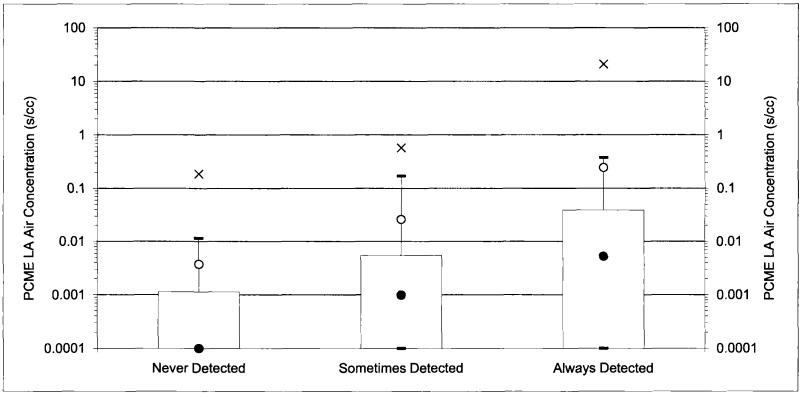
Figure 4-7. Outdoor ABS Air Concentrations Stratified by Visual Vermiculite Detection Status Across Rounds

Vis (+) = visible vermiculite was detected at one or more sampling nodes.

-	AB	S Air Data											
			Percentile (s/cc)													
Visible Detection Status	<u>N</u>	DF	Max (s/cc)	Mean (s/cc)	0.95	0.75	0.5	0.25	0.05							
Never Detected	96	39%	0.19	0.0038	0.012	0.0011	0	0	0							
Sometimes Detected	144	58%	0.58	0.026	0.17	0.0055	0.001	0	0							
Always Detected	204	67%	21	0.24	0.38	0.039	0.0052	0	0

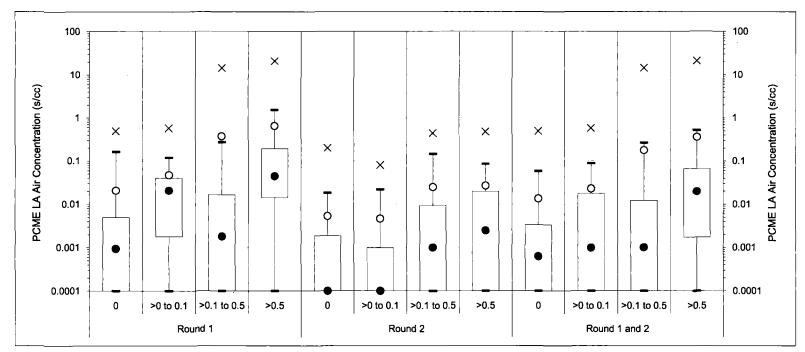
Figure 4-8. Outdoor ABS Air Concentrations Stratified by Visible Detection Frequency Ranking

>0.1 to 0.5 visible vermiculite present in ≤ 50% of visual inspection points

>0.5 visible vermiculite present in more than 50% of visual inspection points

Figure 4-8 presents a graph that shows the distribution of PCME LA concentrations measured in ABS air stratified into four bins, depending on the <u>frequency</u> that visible vermiculite was observed in each ABS area during the visible soil inspection (see Table 4-6). Figure 4-9 presents a similar figure, except that ABS areas are stratified according to the average <u>visible vermiculite score</u> (see Table 4-6) rather than the detection frequency. As seen, in both cases there is a general tendency for the mean concentration of PCME LA in ABS air to increase as the detection frequency or visible vermiculite score in soil increases.

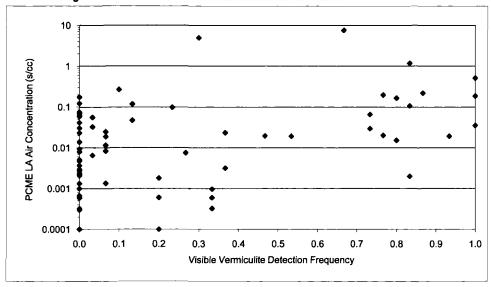
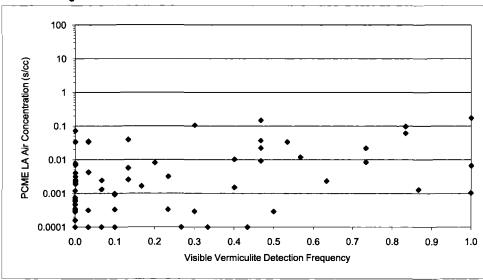
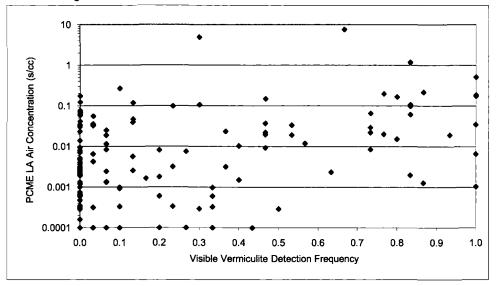
Figure 4-10. Outdoor ABS Air Concentrations as a Function of Visible Detection Frequency

Panel A: Average of all Air Concentrations Across Scenarios for Round 1

Panel B: Average of all Air Concentrations Across Scenarios for Round 2

Panel C: Average of all Air Concentrations Across Scenarios For Both Rounds

For plotting on a log scale, non-detects are assigned a value of 0.0001 s/cc (the x-axis). Average air concentrations are plotted vs. the visible detection frequency from the 30-pt soil sample.

Inspection of these graphs re-emphasizes the relative high variability in ABS air concentrations that is observed, even when variations in soil concentration are accounted for. However, despite the high variability, there is an apparent upward trend in the data as detection frequency (Figure 4-10) or visible score (Figure 4-11) increases.

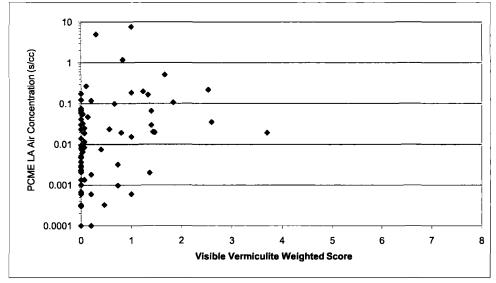
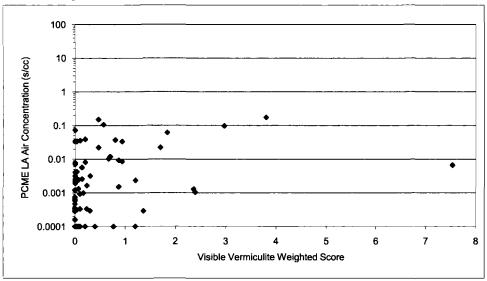
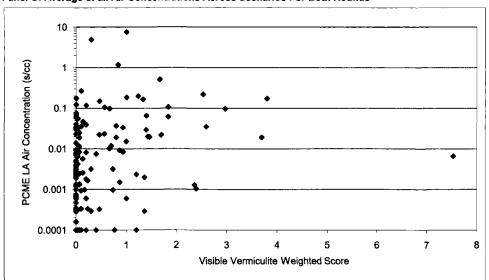
Figure 4-11. Outdoor ABS Air Concentrations as a Function of Visible Vermiculite Weighted Score

Panel A: Average of all Air Concentrations Across Scenarios for Round 1

Panel B: Average of all Air Concentrations Across Scenarios for Round 2

Panel C: Average of all Air Concentrations Across Scenarios For Both Rounds

For plotting on a log scale, non-detects are assigned a value of 0.0001 s/cc (the x-axis). Average air concentrations are plotted vs. the visible detection frequency from the 30-pt soil sample.

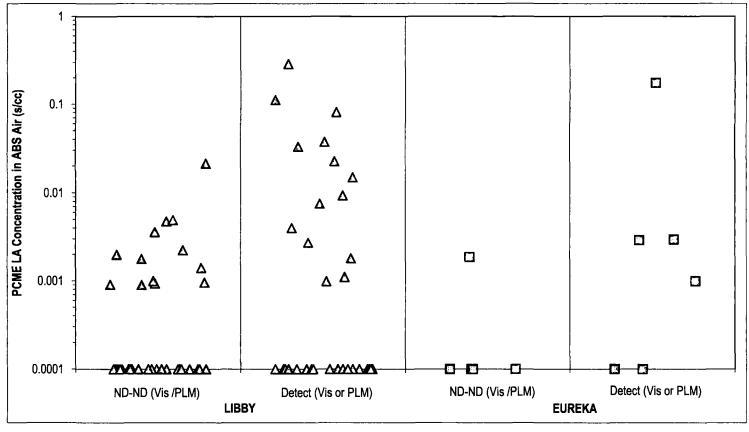
Figure 4-12. Outdoor ABS Data for Clean Fill Locations

Non-detects are shown at 0.0001 s/cc.

ſ	Clean Fill	Soil Status		N				
L	Source	Sul Status	properties	samples	Conc (s/cc)			
ſ	Libby	ND-ND	7	42	1.1E-03			
L	Libby	Detect	6	36	1.7E-02			
Γ	Eureka	ND-ND	1	6	3.1E-04			
L	Luieka	Detect	1	6	3.0E-02

Figure 4-12 shows the ABS data from these 15 locations, stratified by source of the fill material (Libby = triangles, Eureka = squares) and by the PLM and visual vermiculite observations of the soil at the time of the ABS activity. Contrary to what might have been expected, LA and/or visible vermiculite was observed in ABS areas that had clean fill, both from Libby and Eureka. As shown in the figure, there tends to be wide variability in the ABS results and substantial overlap of the data for Libby and Eureka soils. Mean concentrations of PCME LA in ABS air tend to be higher for locations where soil contamination was detected than for areas where it was not detected. However, in considering this observation, it is important to recognize that mean values can be strongly influenced by a few high data points, and that additional data would be needed to strengthen this conclusion. When results for Libby and Eureka are compared for similar soil levels, the results are generally similar. This suggests that the source of the fill material may not be a critical issue. However, because of the limited size of the dataset for areas with fill from Eureka, it is important to recognize that this conclusion is not certain.

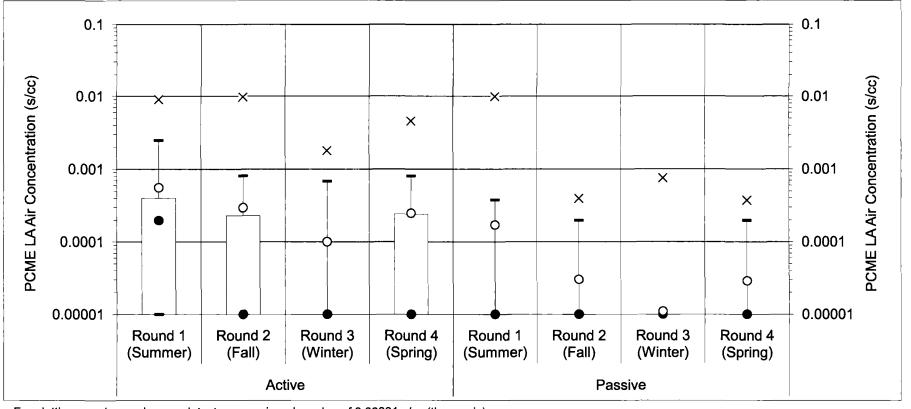
Figure 5-2. Indoor ABS Air Concentrations Stratified by ABS Scenario and Sampling Round

ABS Air Dat	a				
	i [	N		Ī		Percentile (s/cc)					
Scenario	Round		DF	Max (s/cc)	Mean (s/cc)	0.95	0.75	0.5	0.25	0.05	
	Round 1	81	58%	0.009	0.00056	0.0025	0.0004	0.0002	0	0	
A akirra	Round 2	80	34%	0.01	0.0003	0.00081	0.00023	0	0	0	
Active	Round 3	80	14%	0.0018	0.0001	0.00068	0	0	0	0	
	Round 4	80	44%	0.0046	0.00025	0.00081	0.00024	0	0	0	
	Round 1	81	19%	0.01	0.00017	0.00038	0	0	0	0	
Passive	Round 2	80	14%	0.00039	0.00003	0.0002	0	0	0	0	
Passive	Round 3	80	3%	0.00075	0.000011	0	0	0	0	0	
	Round 4	80	14%	0.00037	0.000029	0.0002	0	0	0	0

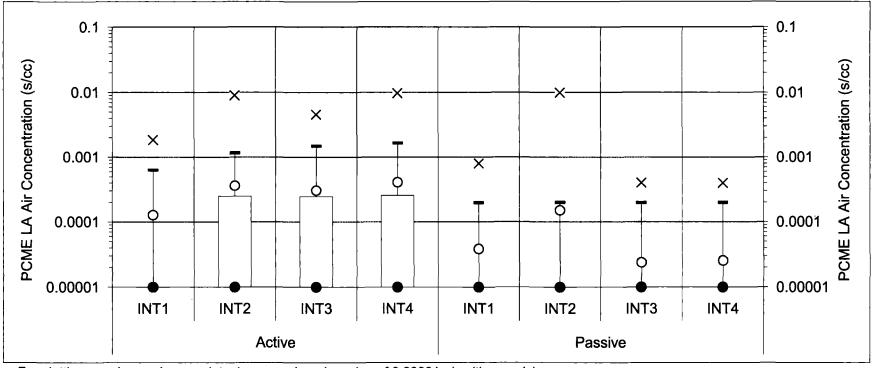
Figure 5-3. Indoor ABS Air Concentrations Stratified by Interior Category

ABS Air Data									
	Interior			Max	Mean		P	ercentile (s/	cc)			
Scenario	Category	N	DF	(s/cc)	(s/cc)	0.95	0.75	0.5	0.25	0.05		
	INT1	76	24%	0.0018	0.00013	0.00064	0	0	0	0		
Antivo	INT2	84	44%	0.009	0.00036	0.0012	0.00025	0	0	0		
Active	INT3	79	42%	0.0046	0.0003	0.0015	0.00025	0	0	0		
	INT4	80	39%	0.01	0.00041	0.0017	0.00026	0	0	0		
	INT1	76	12%	0.0008	0.000038	0.0002	0	0	0	0		
Dannius	INT2	84	15%	0.01	0.00015	0.0002	0	0	0	0		
Passive	INT3	80	11%	0.0004	0.000024	0.0002	0	0	0	0		
	INT4	80	10%	0.0004	0.000025	0.0002	0	0	0	0

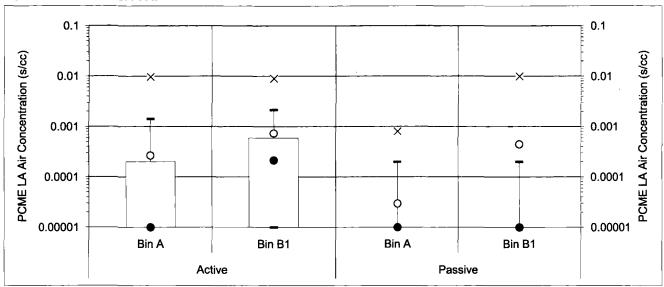
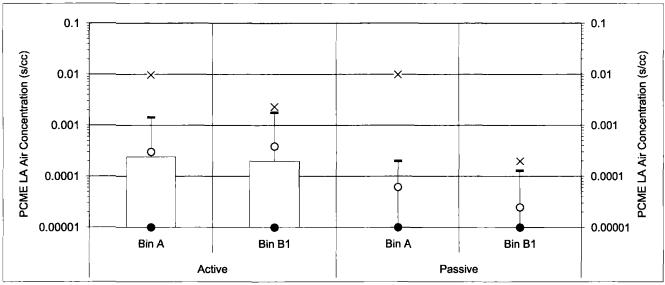
Figure 5-4. Indoor ABS Air Concentrations Stratified by PLM-VE Results

Panel A: Based on SUA Data

Panel B: Based on NSUA Data

·			ABS Air Data									
				Max		Percentile (s/cc)						
Scenario	Soil Bin	N	N DF	(s/cc)	Mean (s/cc)	0.95	0.75	0.5	0.25	0.05		
SUA			<del>.</del>									
Antivo	Bin A	295	36%	0.01	0.00027	0.0014	0.0002	0	0	0		
Active	Bin B1	24	58%	0.009	0.00074	0.0021	0.00059	0.00021	0	0		
Deseive	Bin A	296	11%	0.0008	0.00003	0.0002	0	0	0	0		
Passive	Bin B1	24	21%	0.01	0.00045	0.0002	0	0	0	0		
NSUA		•										
Active	Bin A	311	38%	0.01	0.0003	0.0014	0.00024	0	0	0		
Acuve	Bin B1	8	25%	0.0023	0.00039	0.0018	0.0002	0	0	0		
Deseive	Bin A	312	12%	0.01	0.000062	0.0002	0	0	0	0		
Passive	Bin B1	- 8	13%	0.0002	0.000025	0.00013	0	0	0	0

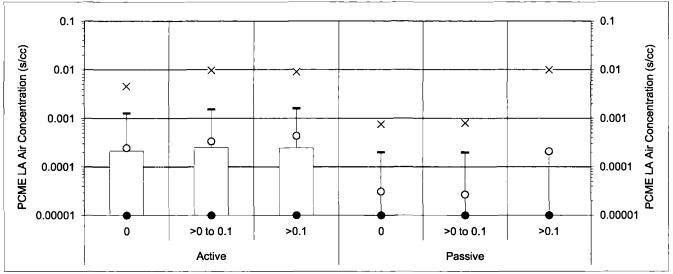
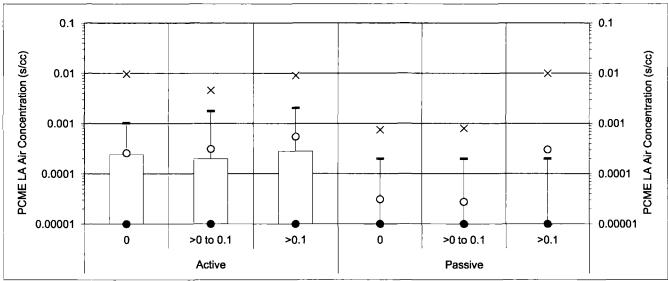
Figure 5-5. Indoor ABS Air Concentrations Stratified by Visible Detection Frequency

Panel A: Based on SUA Data

Panel B: Based on NSUA Data

_		ABS Air Data								
			[	1 1			Percentile (s/cc)			
Scenario	DF Bin	N	DF	Max (s/cc)	Mean (s/cc)	0.95	0.75	0.5	0.25	0.05
SUA										
	0	175	37%	0.0046	0.00024	0.0013	0.00021	0	0	0
Active	>0 to 0.1	88	35%	0.01	0.00033	0.0015	0.00025	0	0	0
	>0.1	56	43%	0.009	0.00043	0.0016	0.00024	0	0	0
	0	176	12%	0.00075	0.000031	0.0002	0	0	0	0
Passive	>0 to 0.1	88	10%	0.0008	0.000027	0.0002	0	0	0	0
	>0.1	56	16%	0.01	0.00021	0.0002	0	0	0	0
NSUA										
	0	212	38%	0.01	0.00026	0.001	0.00024	0	0	0
Active	>0 to 0.1	71	31%	0.0046	0.00031	0.0018	0.0002	0	0	0
	>0.1	36	47%	0.009	0.00055	0.002	0.00028	0	0	0
	0	212	12%	0.00075	0.000031	0.0002	0	0	0	0
Passive	>0 to 0.1	72	10%	0.0008	0.000028	0.0002	0	0	0	0
L	>0.1	36	17%	0.01	0.0003	0.0002	0	0	0	0

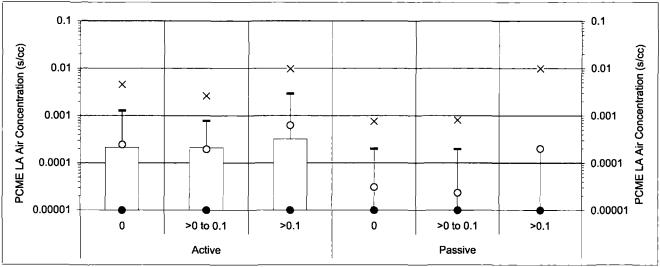
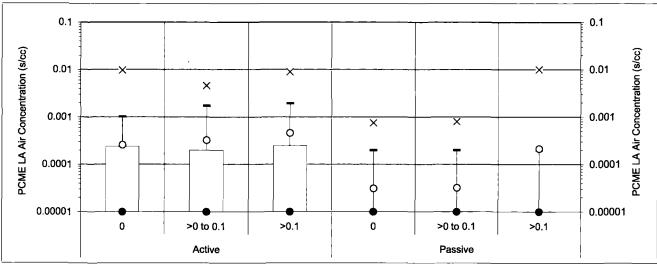
Figure 5-6. Indoor ABS Air Concentrations Stratified by Visible Vermiculite Weighted Score

## Panel A: Based on SUA Data

Panel B: Based on NSUA Data

For plotting on a log scale, non-detects are assigned a value of 0.00001 s/cc (the x-axis).

ABS Air Data								
							Percentile (s/cc)			
Scenario	Score Bin	N	DF	Max (s/cc)	Mean (s/cc)	0.95	0.75	0.5	0.25	0.05
SUA							<del></del>			
	0	175	37%	0.0046	0.00024	0.0013	0.00021	0	0	0
Active	>0 to 0.1	84	33%	0.0026	0.00019	0.00078	0.00021	0	0	0
	>0.1	60	45%	0.01	0.00062	0.0029	0.00032	0	0	0
	0	176	12%	0.00075	0.000031	0.0002	Ö	0	0	0
Passive	>0 to 0.1	84	8%	0.0008	0.000024	0.0002	0	0	0	0
	>0.1	60	18%	0.01	0.0002	0.0002	0	0	0	0
NSUA										
	0	212	38%	0.01	0.00026	0.001	0.00024	0	0	0
Active	>0 to 0.1	55	31%	0.0046	0.00032	0.0017	0.0002	0	0	0
	>0.1	52	42%	0.009	0.00046	0.0019	0.00025	0	0	Ö
	0	212	12%	0.00075	0.000031	0.0002	0	0	0	0
Passive	>0 to 0.1	56	11%	0.0008	0.000032	0.0002	0	0	0	0
	>0.1	52	13%	0.01	0.00021	0.0002	0	0	0	0

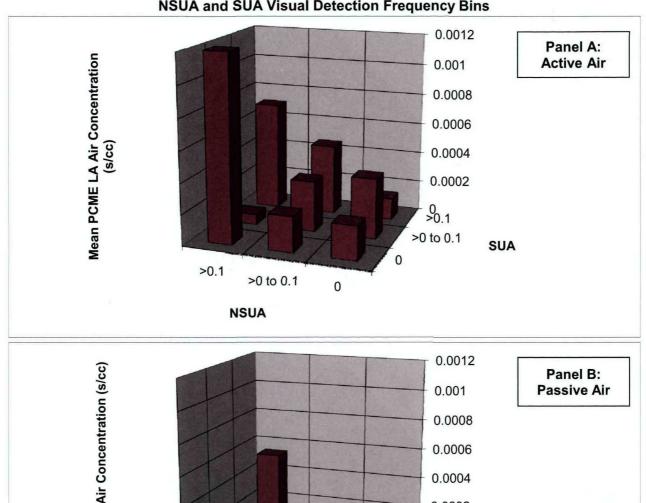
Figure 5-7. Mean PCME LA Air Concentration Stratified by NSUA and SUA Visual Detection Frequency Bins

on (s/cc)			0.001	Panel B: Passive Air
iratio			0.0008	
ncent			0.0006	
S S			0.0004	
Ā Š			0.0002	
Mean PCME LA Air Concentration (s/cc)	>0.1		0 > 0.1 ) to 0.1	SUA
_	>0 to 0.1	0		
	NSUA

Active Mean PCME LA Concentration (s/cc)		SUA				
		0	>0 to 0.1	>0.1		
NSUA	0	0.00022	0.00039	0.00014		
	>0 to 0.1	0.00023	0.00033	0.00046		
	>0.1	0.0012	0.000066	0.00071

Count of Samples		SUA				
		0	>0 to 0.1	>0.1		
NSUA	0	136	56	20		
	>0 to 0.1	35	20	16		
	>0.1	4	12	20

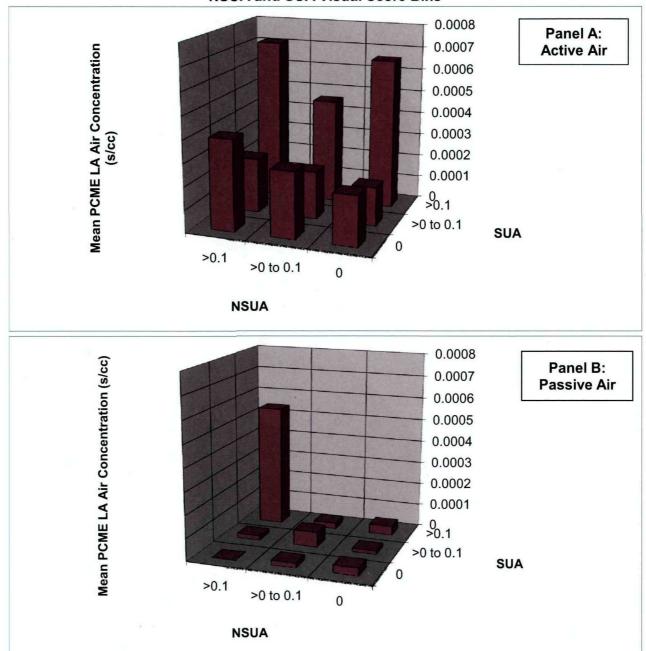
Figure 5-8. Mean PCME LA Air Concentration Stratified by NSUA and SUA Visual Score Bins

Active Mean PCME LA		SUA				
Concentration (s/cc)		0	>0 to 0.1	>0.1		
	0	0.00022	0.00017	0.00066		
NSUA	>0 to 0.1	0.00029	0.00021	0.00046		
	>0.1	0.0004	0.00024	0.00071

Passive Mean PCME LA Concentration (s/cc)		SUA			
		0	>0 to 0.1	>0.1	
	0	0.000035	0.000015	0.00004	
NSUA	>0 to 0.1	0.000021	0.000067	0.000025	
	>0.1	0	0.00002	0.00054

Count of Samples		SUA				
		0	>0 to 0.1	>0.1		
	0	34	13	6		
NSUA	>0 to 0.1	7	4	4		
	>0.1	3	5	5

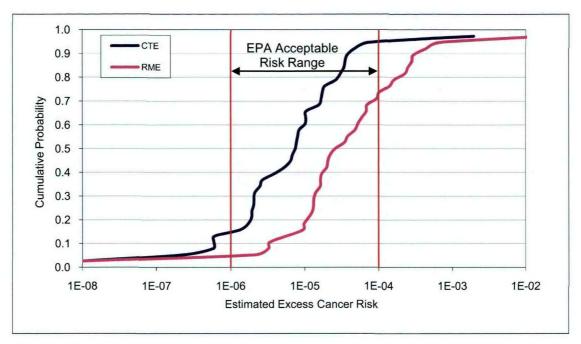
Figure 6-3. Distribution of Screening Level Total Risk Estimates^a at Properties with Both Indoor and Outdoor ABS Data

^a Total Risk = Outdoor ABS Risk + Indoor, active ABS Risk + Indoor, passive ABS Risk

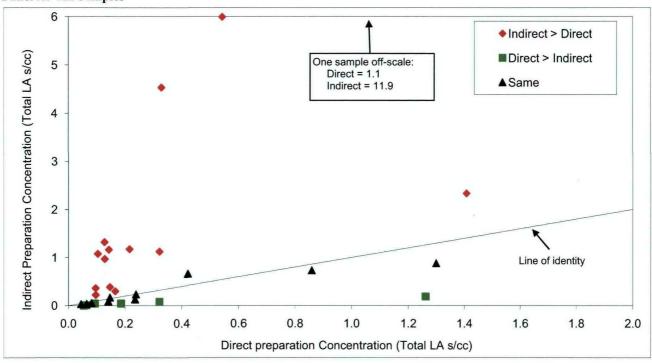
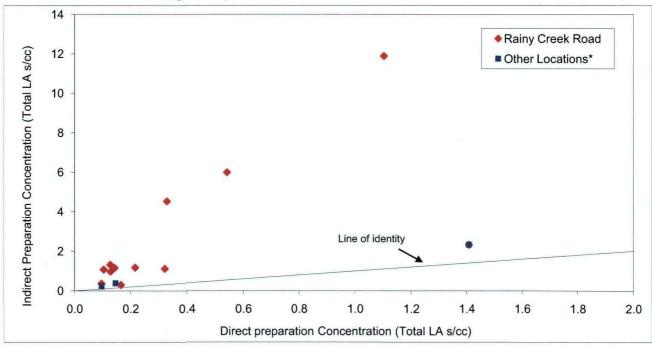
Figure 6-4. Comparison of Direct and Indirect TEM Results for 31 Air Samples from Libby

Panel A: All Samples

Panel B: Indirect > Direct Samples Only

If air samples were deemed to be overloaded, samples were prepared indirectly in accord with the procedures in SOP EPA-LIBBY-08. In brief, in an indirect preparation, rinsate or ashed residue from the original filter is suspended in water and sonicated, and an aliquot of this water is applied to a second filter which is then used to prepare a set of TEM grids. If there was no loose material present in the air cassette or adhering to the cowl, the indirect preparation method was performed as specified in ISO 13794, except that the total solution volume was increased from 40 mL to 100 mL, and a portion of the original filter was retained. If there was loose material present in the air cassette or adhering to the cowl, the indirect preparation procedure was performed as specified in ASTM D-5755, except that an ashing of the primary filter was included. A discussion of the potential influence of indirect preparation techniques on reported TEM air concentrations is presented in Section 6.4.

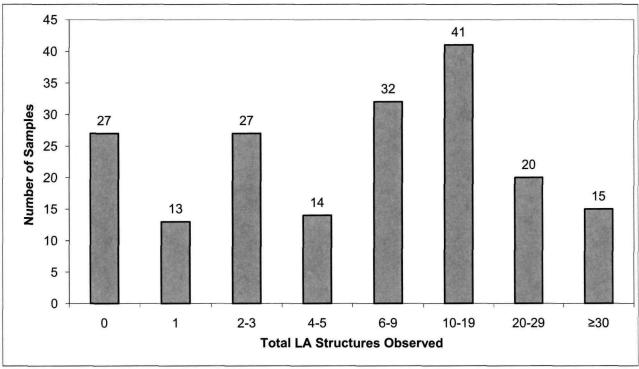
Figure 7-3. Number of LA Structures Observed in Outdoor ABS Air Samples†

† For samples where analysis was stopped based on maximum number of grid openings counted of 100.
